**UPPER MISSISSIPPI RIVER SYSTEM  
ENVIRONMENTAL MANAGEMENT PROGRAM  
POST-CONSTRUCTION PERFORMANCE  
EVALUATION REPORT – YEAR 8 (2000)**

**ANDALUSIA REFUGE  
HABITAT REHABILITATION  
AND ENHANCEMENT**

**US Army Corps  
of Engineers**  
Rock Island District

**POOL 16  
MISSISSIPPI RIVER MILES 462.0 – 463.0  
ROCK ISLAND COUNTY, ILLINOIS**

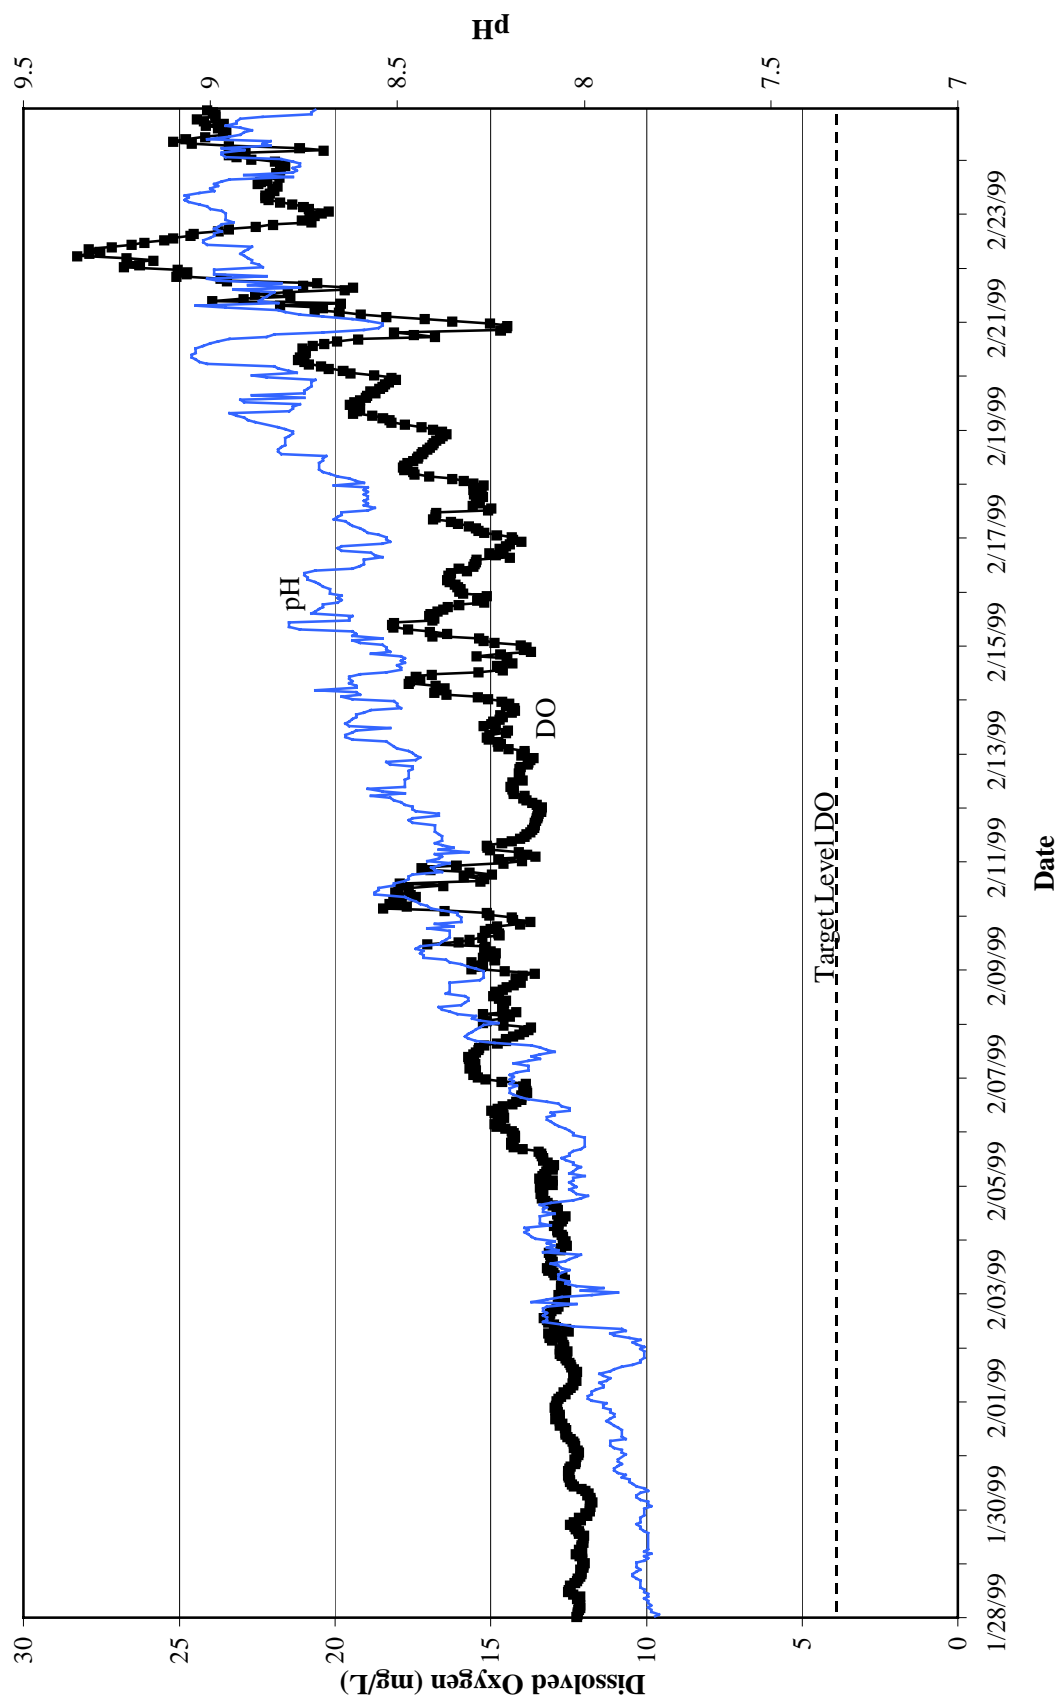
**FIGURE E-1. Post-Project Dissolved Oxygen and pH Values Collected with a Continuous Monitor at Station W-M462.5O**

In-situ continuous monitors were deployed at Station W-M462.5O on 27 occasions (6 during the winter months and 21 during the summer months). All winter DO concentrations were above the target level and supersaturated conditions were common. Figure E-1 in Appendix E is an example of DO and pH data collected during the winter with a continuous monitor. The graph depicts DO and pH values during the January 28

through February 25, 1999 deployment. Supersaturated DO conditions existed for approximately half the deployment period. The lowest DO concentration observed was 11.73 mg/L, while the highest value observed was 28.27 mg/L. In general, pH values paralleled DO concentrations. The lowest pH value observed was 7.80, while the highest value observed was 9.07. This relatively high value is most likely due to algal photosynthesis.

**Figure E-1. Monitoring Results at Station W-M462.5O during Winter 1999**

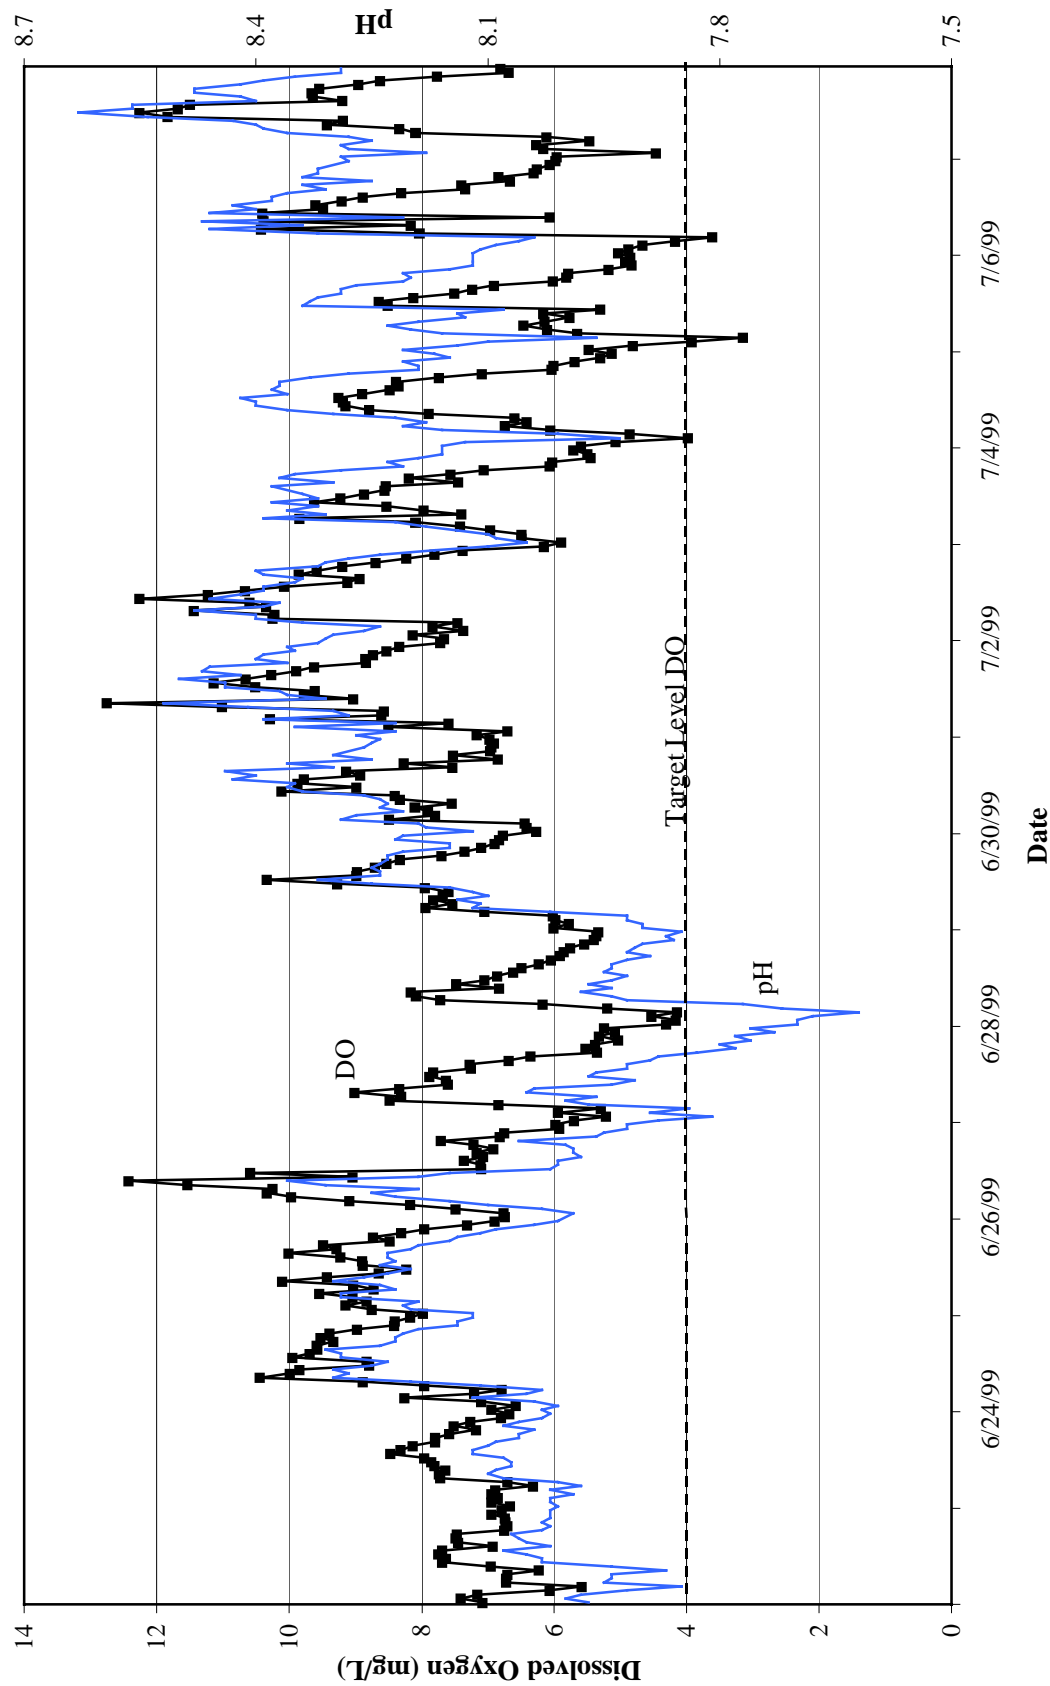
**FIGURE E-2. Post-Project Dissolved Oxygen and pH Values Collected  
with a Continuous Monitor at Station W-M462.5O**

**Figure E-2. Monitoring Results at Station W-M462.5O during Summer 1999**
